NASA TN D-3429

**COMPATIBILITY OF COLUMBIUM  
AND TANTALUM TUBING ALLOYS  
WITH REFLUXING POTASSIUM**

*by Coulson M. Scheuermann and Charles A. Barrett*

*Lewis Research Center*

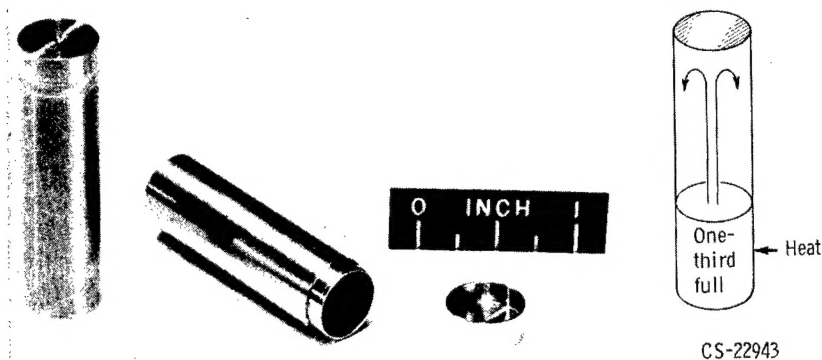
Figure 1. - Reflux capsule used in potassium corrosion study.

The corrosion resistance of the various potential tubing alloys to potassium was determined by means of reflux capsules (fig. 1), the capsule wall serving as the test specimen. In capsule tests such as these, liquid is vaporized from a pool at the bottom of the capsule and is condensed near the top of the capsule. The condensate then flows down the capsule wall and joins the bulk liquid, completing the circuit.

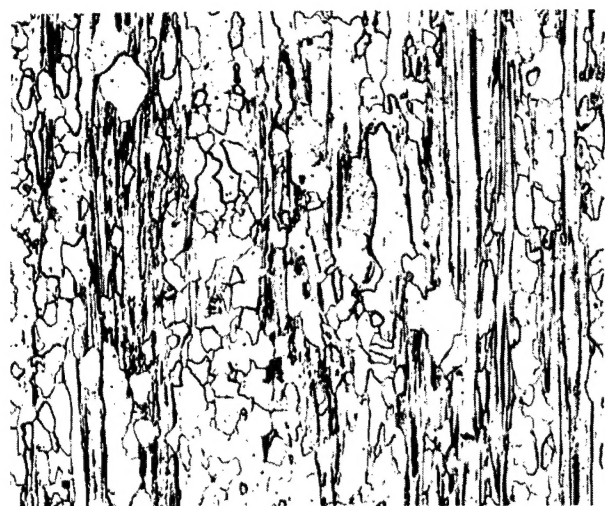
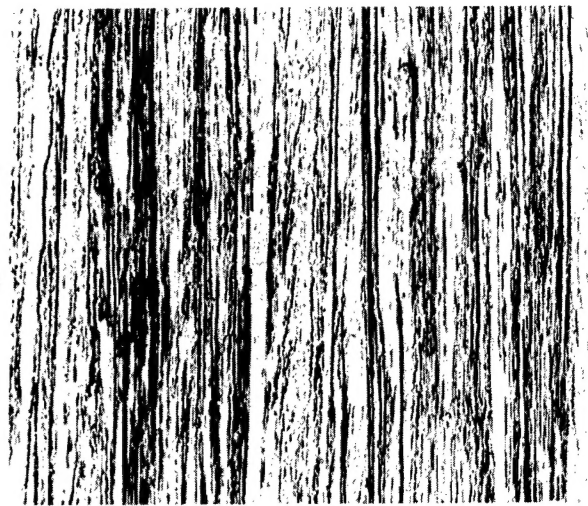
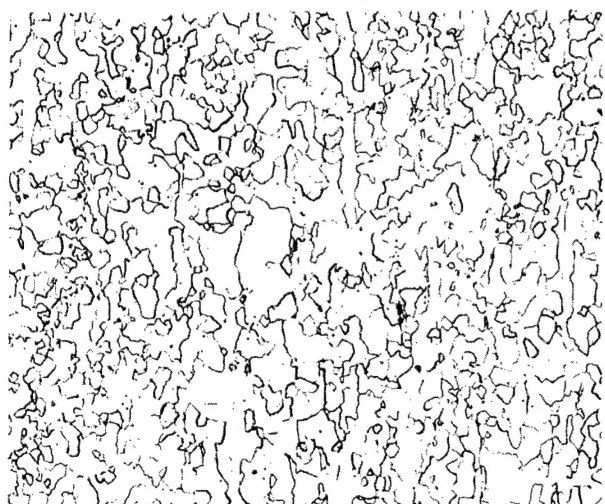
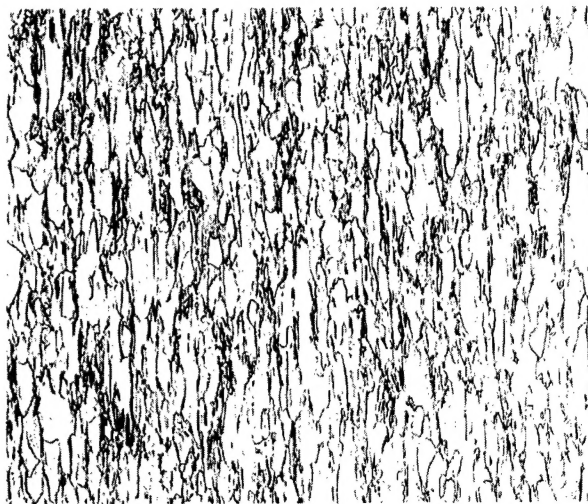
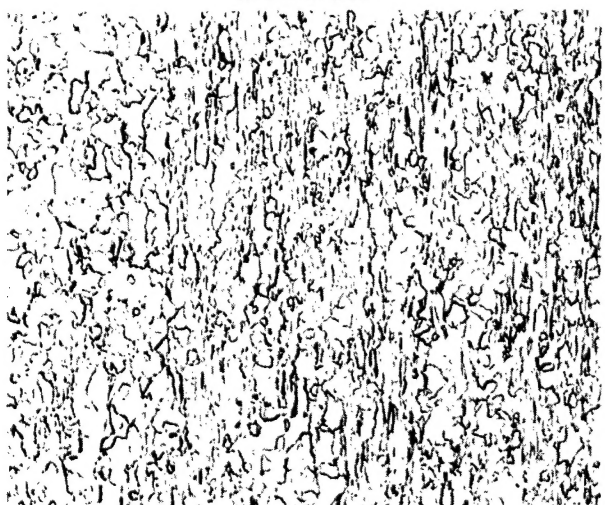
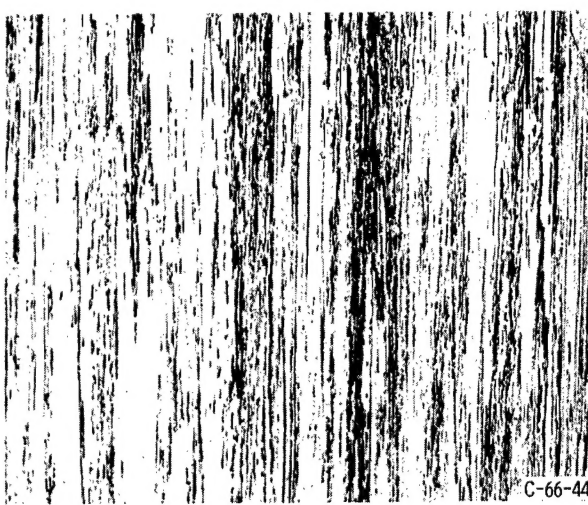
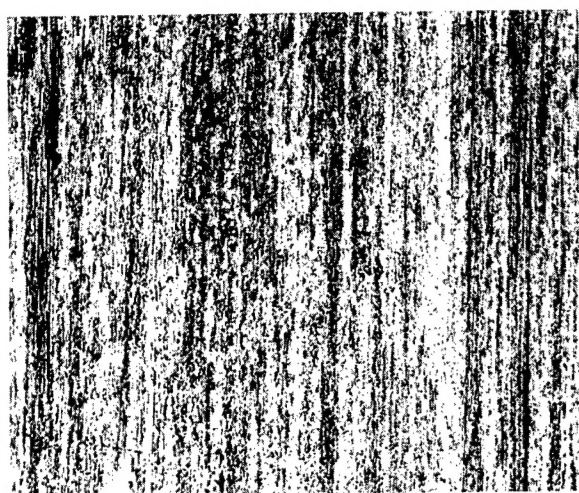
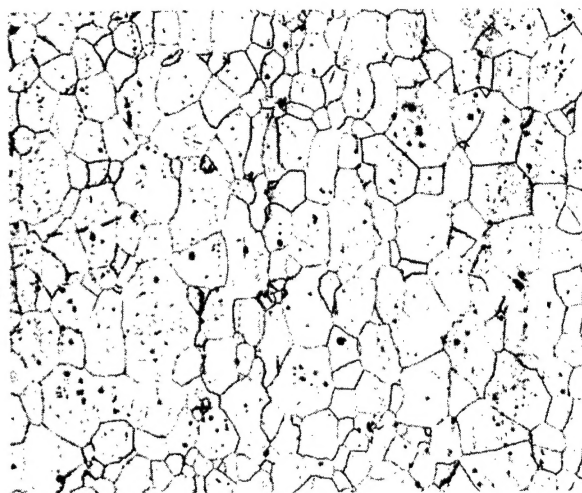
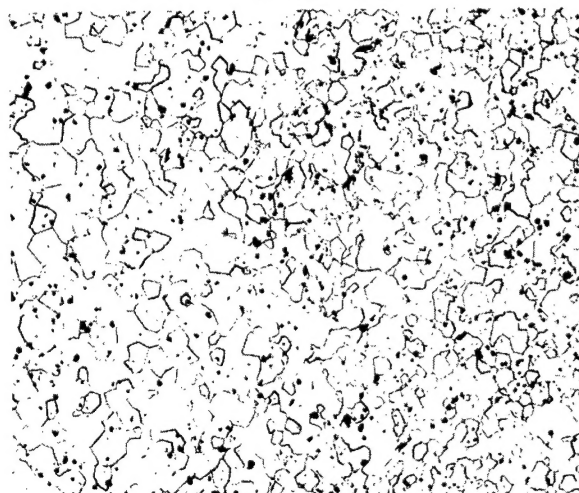
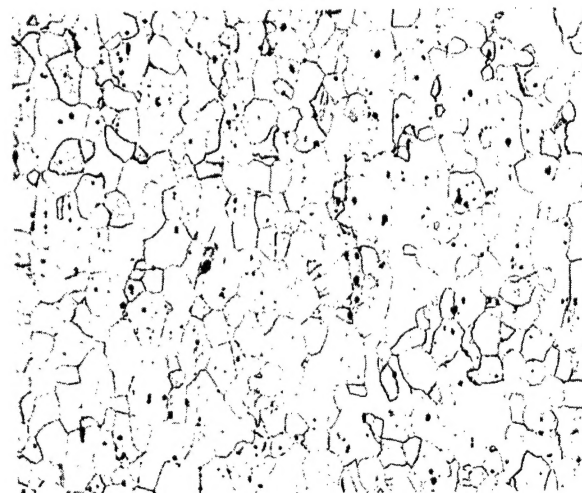
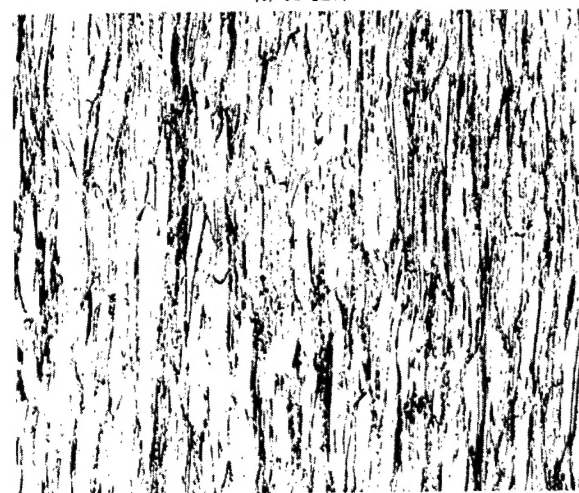
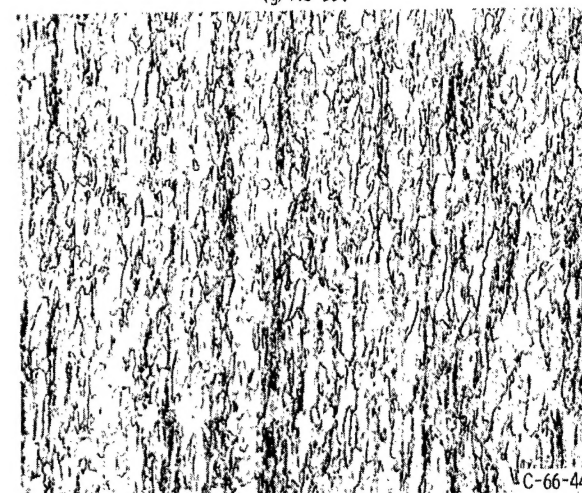
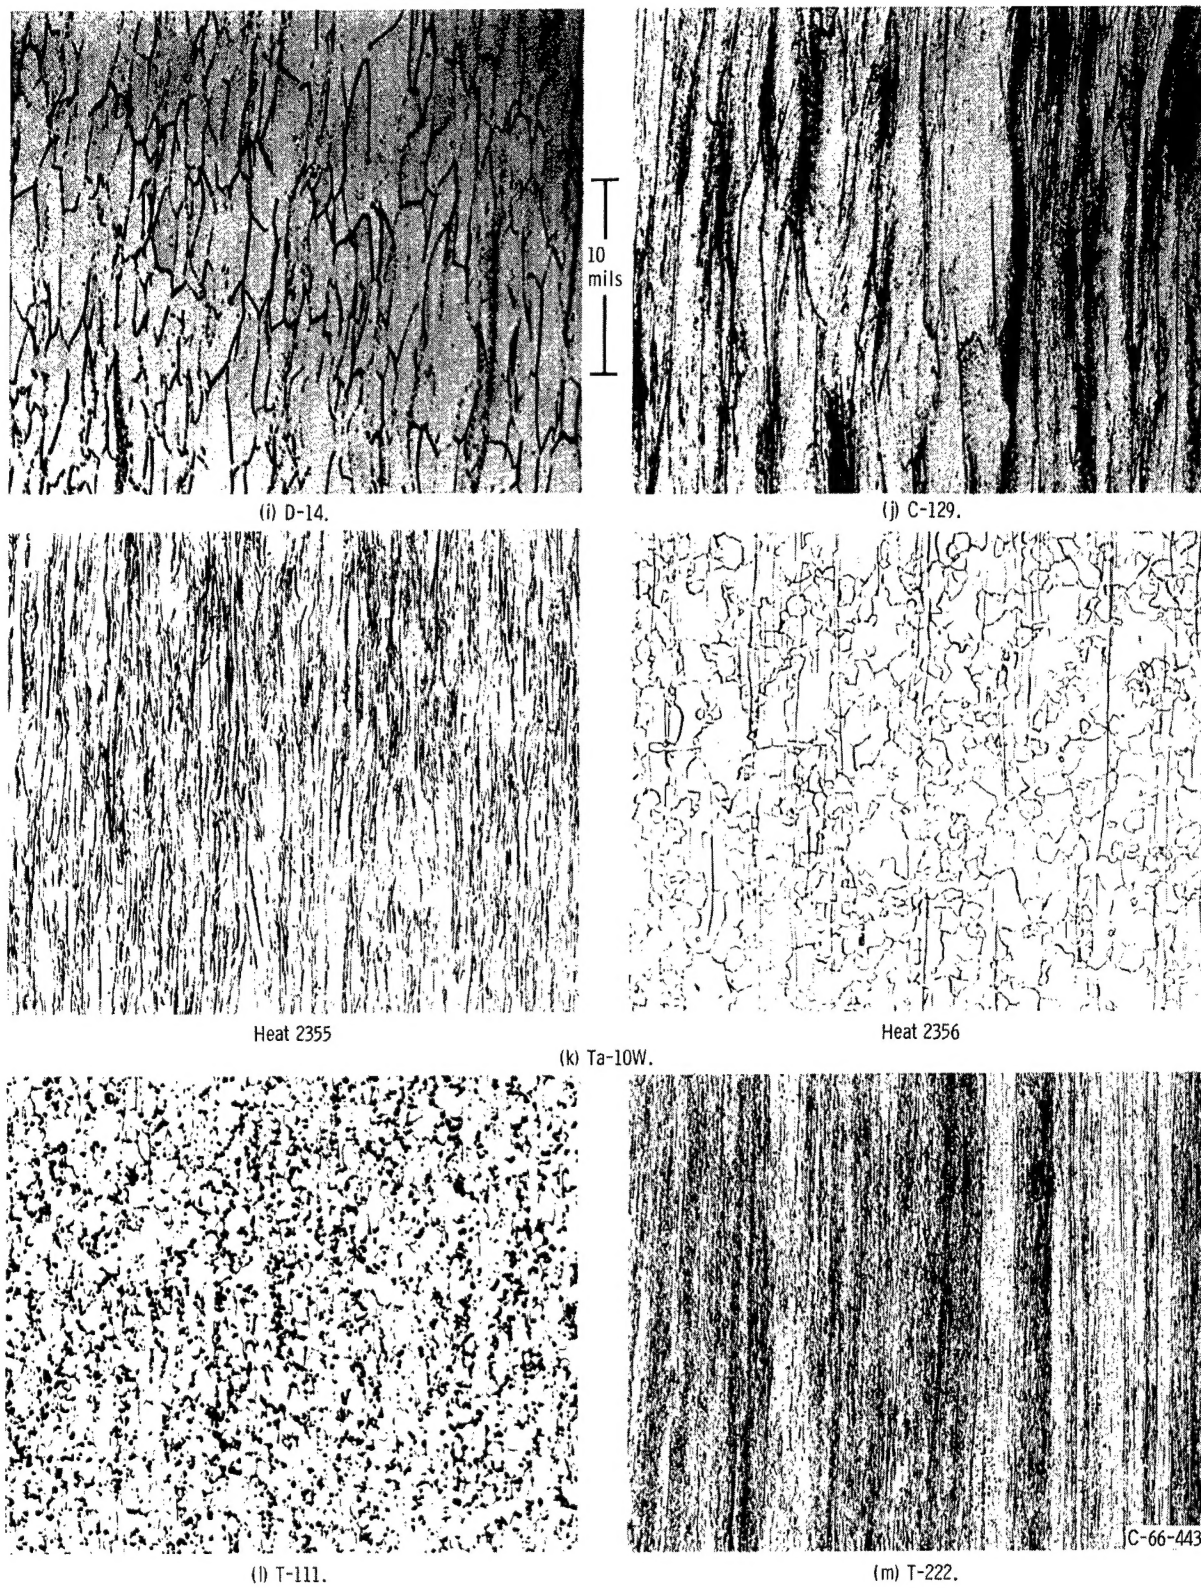
Figure 2. - Microstructures of as-received rod stock.

The alloys evaluated and their compositions are given in table I. The alloys were in the worked condition with the exceptions of AS-55, B-33 (heat XMM-8406), Cb-1Zr (heat 5122), and Ta-10W (heat 2356), which were recrystallized. The microstructures of these materials, as received, are shown in figure 2.

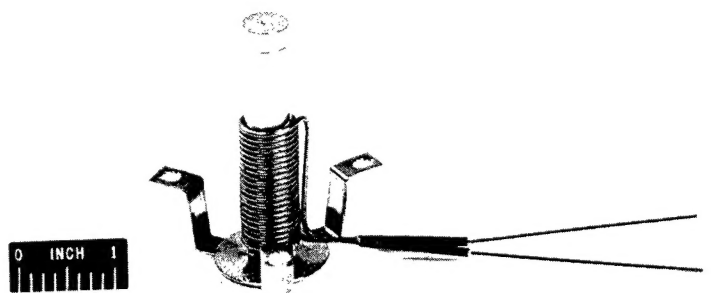
Figure 3. - Coiled tantalum heater.

Testing was performed in high-vacuum chambers at pressures in the  $10^{-7}$  to  $10^{-8}$  torr range. The capsules were heated by tantalum heaters such as that shown in figure 3. Details of construction of these heaters are given in appendix B. Each heater was individually regulated to a set temperature by automatic control equipment. Test temperatures were recorded on multipoint strip-chart recorders. Initial startup conditions and their effects on oxygen contamination are discussed in appendix C. The nominal test

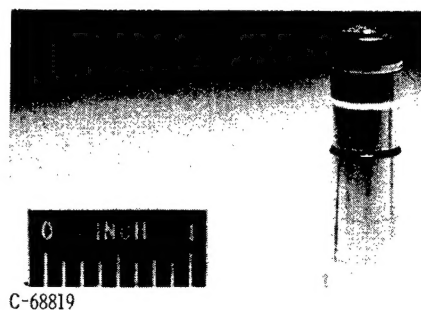
C-68819  
Figure 4. - Typical capsule used to test effect of stress on corrosion.

To explore the possibility of stress-induced corrosion, the hoop stress in the condensing region of the capsules was increased in test runs 4 and 5 by machining the wall to a thickness of approximately 0.020-inch over a 0.350-inch length along the top portion of the capsule (fig. 4).

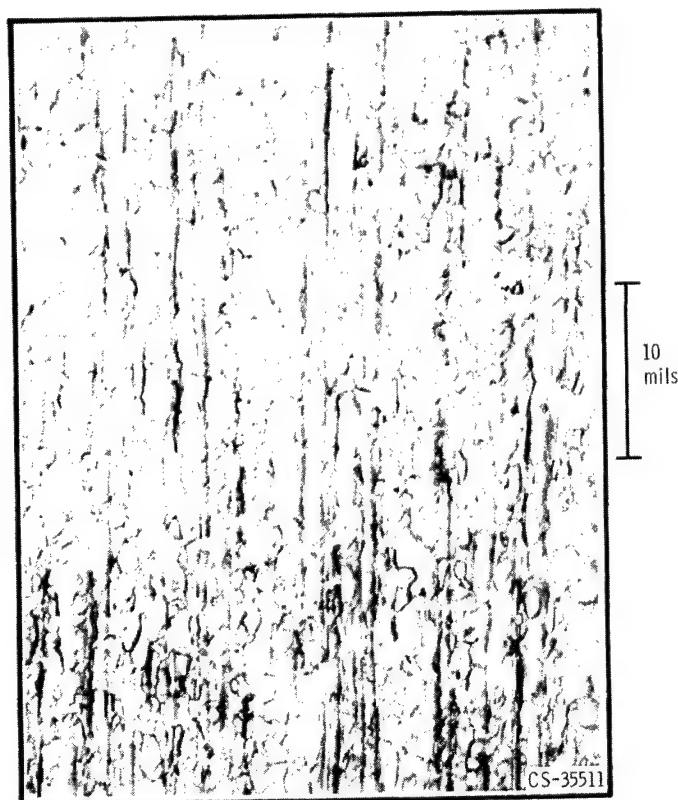
Figure 5. - Microstructure of replica of inside surface of B-33 capsule (heat XMM-8406) tested at 1800° F for 2000 hours with refluxing potassium.

delineation, by the potassium was found (fig. 5), and some general grain growth was observed. The capsule tested at 2200° F for 2000 hours (fig. 6) had much heavier grain delineation and an attack of approximately 1.0 mil at the liquid-vapor interface. In addition, there was up to 1.5 mils of intergranular attack at a corner in the condensing section. Very large grains were found throughout the condensing section and were also present along the inside edge of the capsule at the very bottom of the liquid zone. A test with a capsule from heat XMM-8346 (partially wrought) at 2200° F for 1000 hours yielded similar results, except that the solution attack at the liquid-vapor interface was approximately 3.0 mils deep (fig. 7).

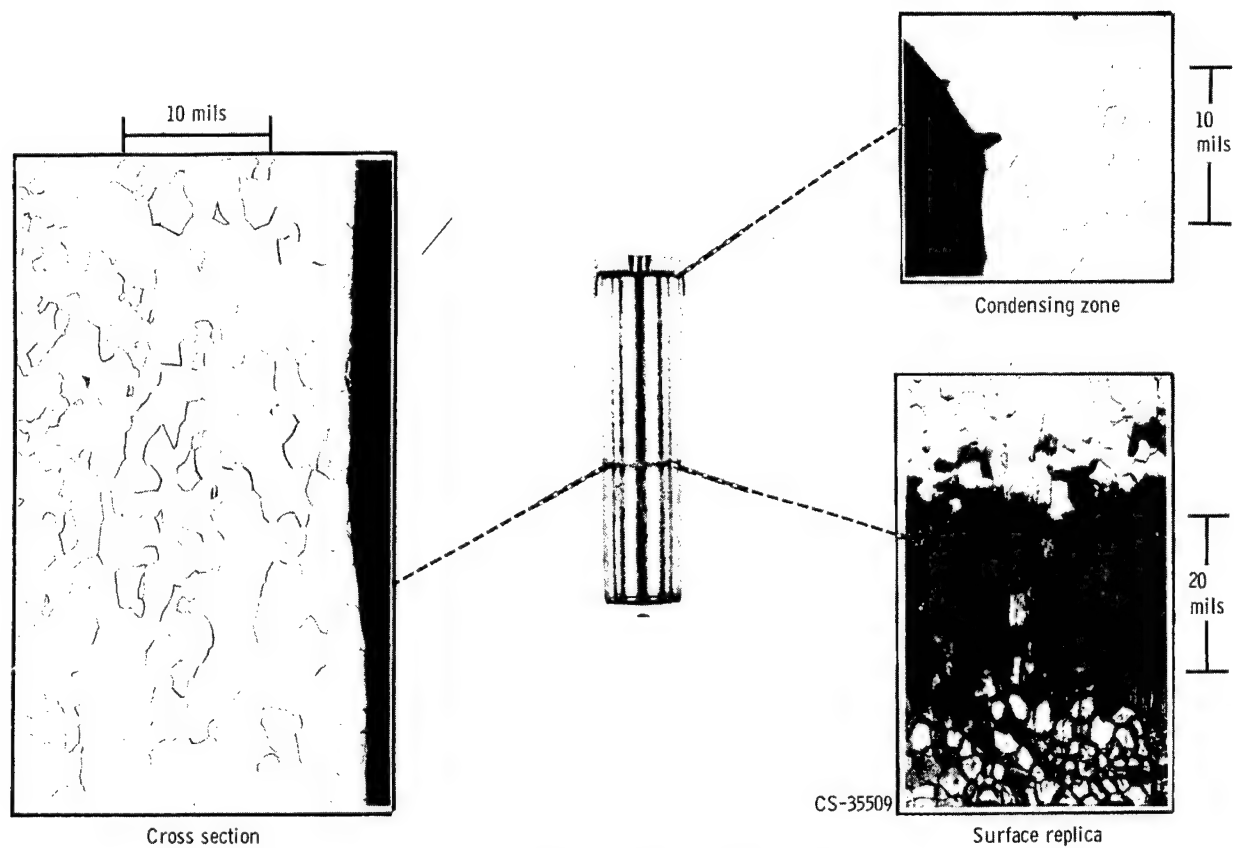
Figure 6. - Microstructure of B-33 capsule (heat XMM-8406) tested at 2200° F for 2000 hours with refluxing potassium.

portion of the capsule should promote the diffusion of oxygen through the wall toward the upper part of the capsule. If the potassium flowing down the inside surface is not saturated with the complex oxide, the oxygen diffusing upward through the wall could contribute to complex-oxide formation and solution of the capsule surface above the liquid pool. The attack observed at the liquid-vapor interface region on the B-33 capsules in figures 6 to 8 was in agreement with this surmise.

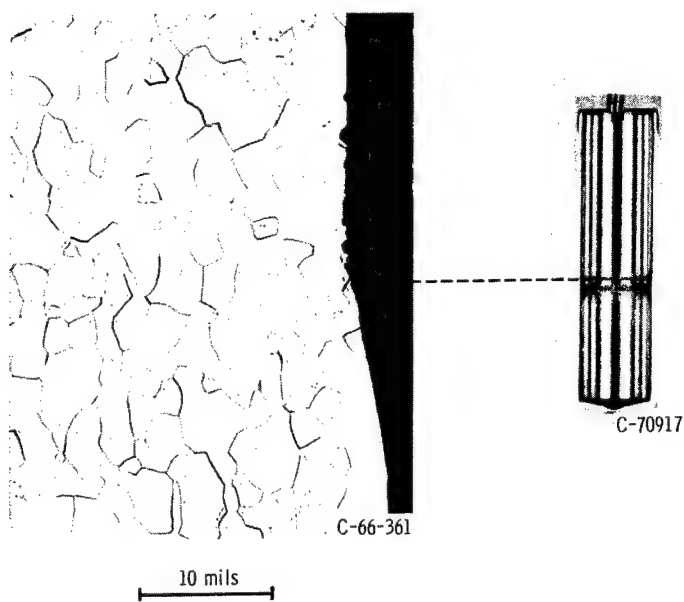
Figure 7. - Microstructure of B-33 capsule (heat XMM-8346) tested at 2200° F for 1000 hours with refluxing potassium.

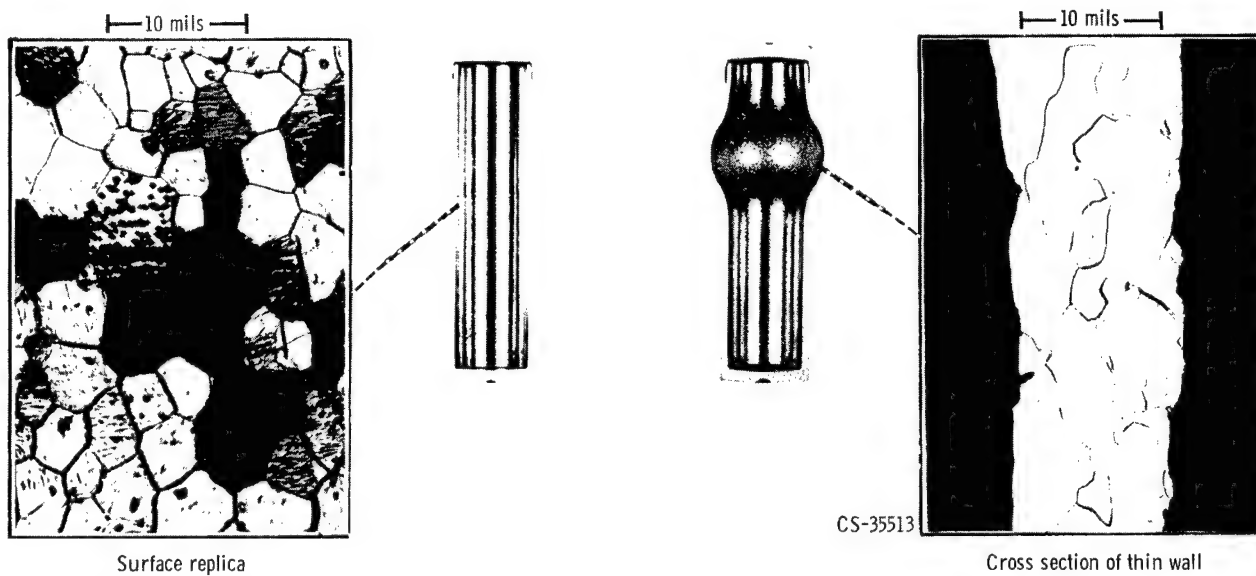
Figure 8. - Effect of stress on corrosion. B-33 capsules (heat XMM-8346) both tested at 2300° F for 380 hours with refluxing potassium.

There did not appear to be any effect of stress on the corrosion of B-33 at 2200° F after 1000 hours. At 2300° F the thin-walled capsule, bearing an initial stress of 3380 pounds per square inch, failed by creep rupture after 380 hours. Failure occurred after a creep strain of 45 percent. A comparison of this capsule with the regular-walled control capsule tested for the same time and at the same temperature is shown in figure 8. The capsule with the original 0.040-inch wall had an initial stress of approximately 1880 pounds per square inch. After the test, the capsule showed the usual grain delineation and a slight attack at the liquid-vapor interface. The grains were extremely large in the condensing section of the capsule and decreased somewhat in size in the liquid section.

The thin-walled portion of the first capsule showed up to 1.0 mil of intergranular attack; otherwise, there appeared to be no significant difference between the two capsules.

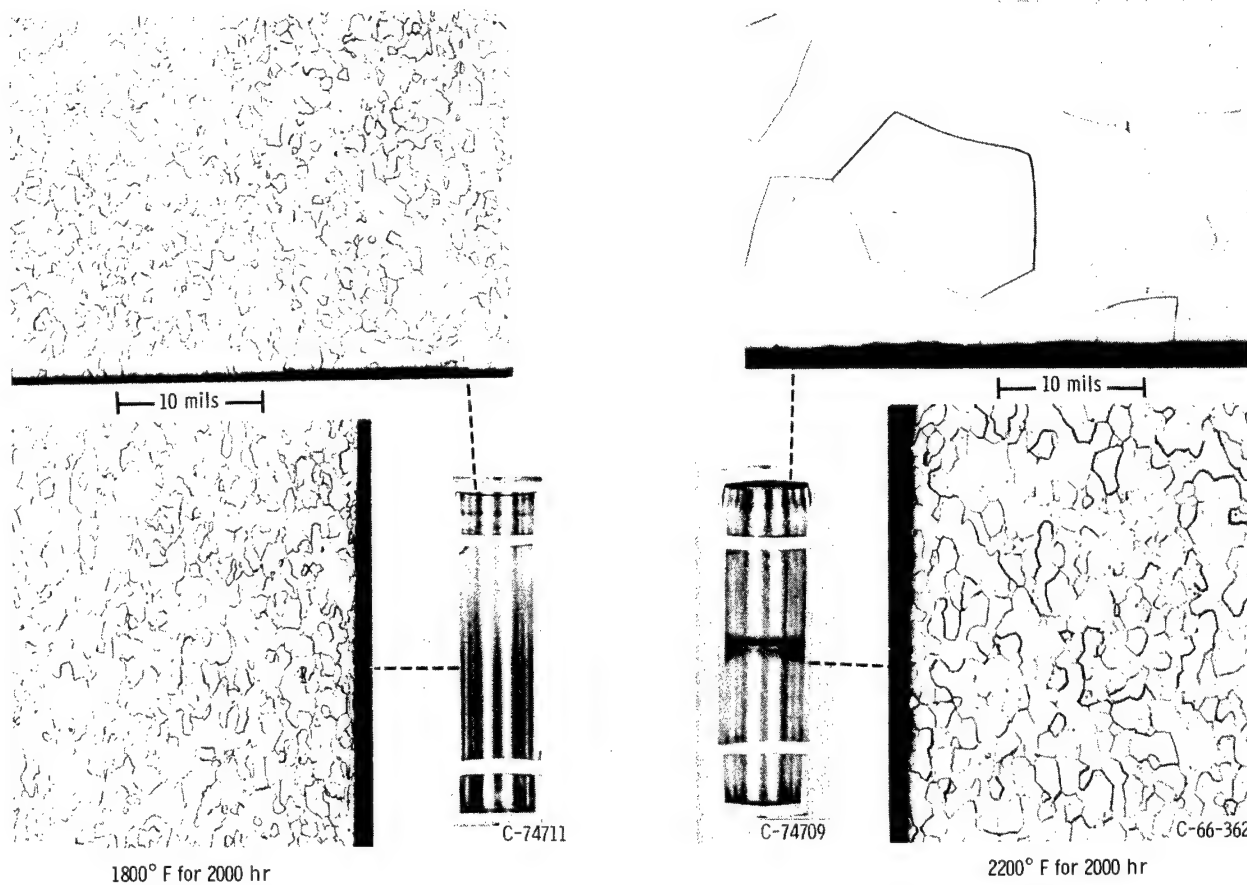
Figure 9. - Microstructures of B-33 capsules (heat XMM-8641) after testing with refluxing potassium.

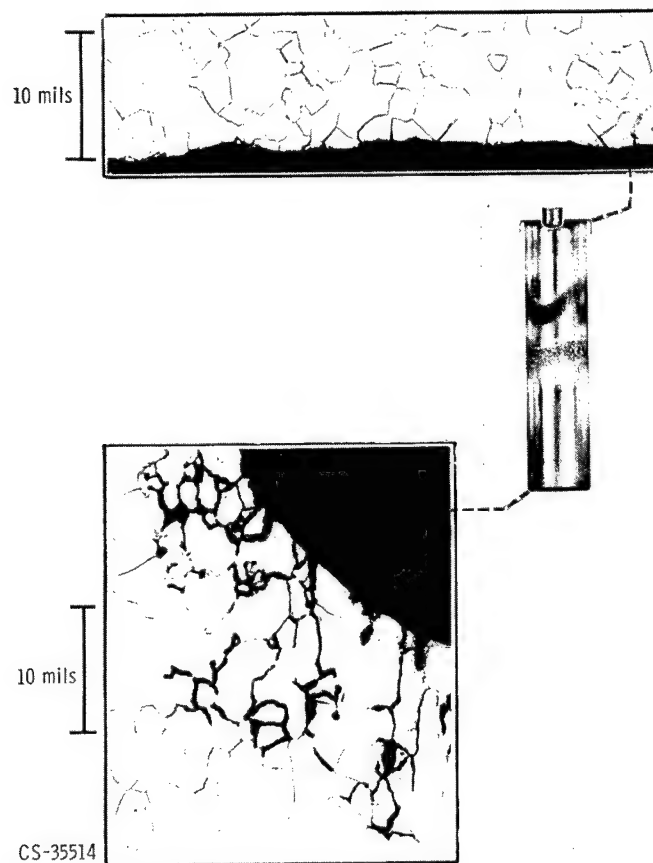
Figure 10. - Microstructures of SCb-291 capsule tested at 2200° F for 1000 hours with refluxing potassium.

At 2200<sup>0</sup> F after 1000 hours, this alloy showed extensive intergranular attack (up to 16 mils) throughout the liquid section and some solution attack in the condensing section (fig. 10). Deposits were evident, and X-ray patterns indicated that the lower band of deposits shown in figure 10 were large crystals of columbium, while the upper band, which was not observable metallographically, was composed of very small columbium crystals and large tungsten crystals. The microstructure was completely recrystallized. Sections of this capsule were analyzed for oxygen (table III). The analysis showed a slightly higher concentration in the bottom section than in the top section.

Case II. - When a source of oxygen is present in the guise of oxygen in the test environment, diffusion through the capsule wall would provide a continuing supply of oxygen for reactions (2) and (3). Under the proper conditions of time and temperature, this would give rise to wall recession through the continuing production of the complex oxide at the columbium-potassium interface and its removal by dissolution into the potassium. Since impurities are known to concentrate at grain boundaries, pronounced intergranular attack could be expected also. These effects were observed in SCb-291 (fig. 10).

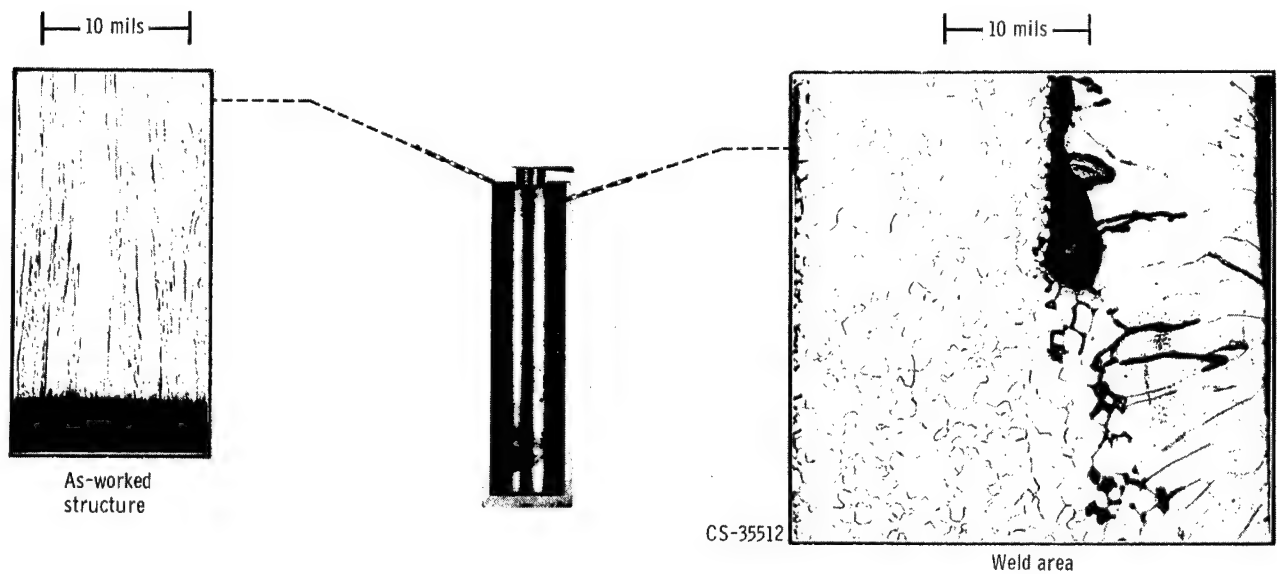
Figure 11. - Microstructure of as-worked Ta-10W capsule (heat 2355) after testing for 110 hours at 1800° F with refluxing potassium.

All Ta-10W capsules tested failed by corrosive attack in less than the planned test time of 1000 hours. The capsule tested at 1800<sup>0</sup> F failed at 110 hours by intergranular penetration through a thin 10-mil section of the weld (fig. 11). There was also up to 1.0 mil of intergranular attack in the recrystallized area surrounding the weld. The worked structure seemed to be unaffected. At 2200<sup>0</sup> F, failure occurred at 8 hours with the same type of attack. Again, the worked structure was unaffected. Results of vacuum-fusion analyses of the weld and a section in the liquid zone of the capsule are given in table III. The bottom section had essentially the same concentration as that of the pretest sample, while the section from the weld area had a slightly higher concentration.

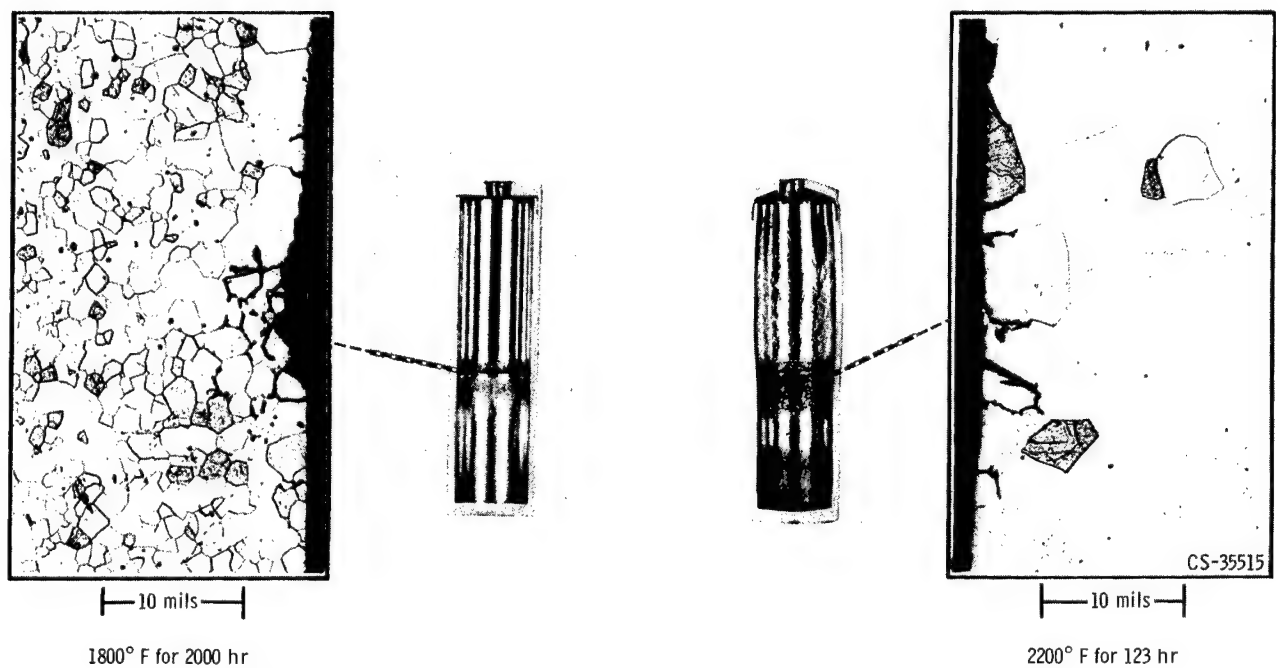
Figure 12. - Microstructures of capsules of Cb-1Zr (heat 5122) after testing with refluxing potassium.

Recrystallized Cb-1Zr (heat 5122) was tested at 1800° F for as long as 2000 hours and at 2200° F for times up to 123 hours (fig. 12). At 1800° F for 2000 hours, there was 7.0 mils of intergranular attack and grain removal at the liquid-vapor interface and 0.8 mil of intergranular attack at the bottom of the capsule. There appeared to be a slight amount of general grain growth during the test and a pronounced grain growth throughout the condensing section down to the liquid-vapor interface, extending to a maximum depth of 6.0 mils. At 2200° F the capsules failed by creep rupture after 54 and 123 hours. The capsule that failed at 123 hours showed 4.5 mils of intergranular attack at the liquid-vapor interface, 1.5 mils of deposit buildup just below the interface, up to 1.5 mils of intergranular attack in the liquid section, and general solution attack at the top of the condensing section. The microstructure exhibited very large grains throughout the capsule. There also appeared to be a fine network of precipitates throughout many of the grains.

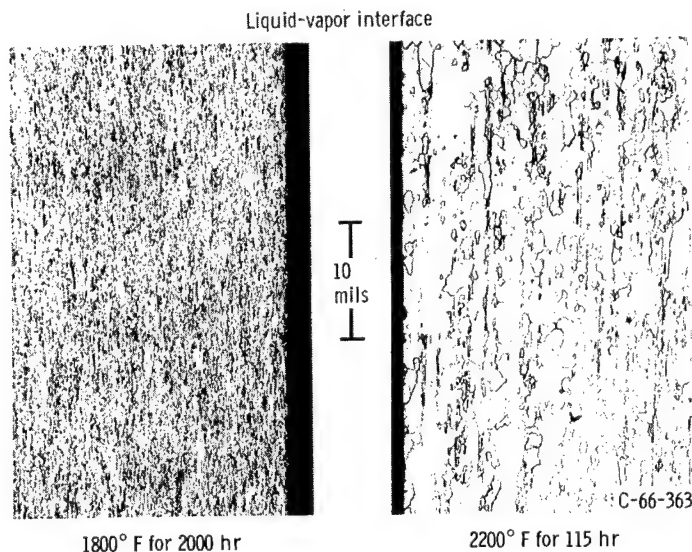
Figure 13. - Microstructures of Cb-1Zr capsules (heat 5118) after testing with refluxing potassium.

up to 115 hours (fig. 13) in the as-received, cold-worked condition. Unlike the results from heat 5122, no intergranular or solution attack was found. Results of vacuum-fusion analyses for oxygen (table III) were found to be similar to the results obtained for B-33, showing greater oxygen contents at the bottom than at the top of each capsule and an increase of oxygen content with temperature.

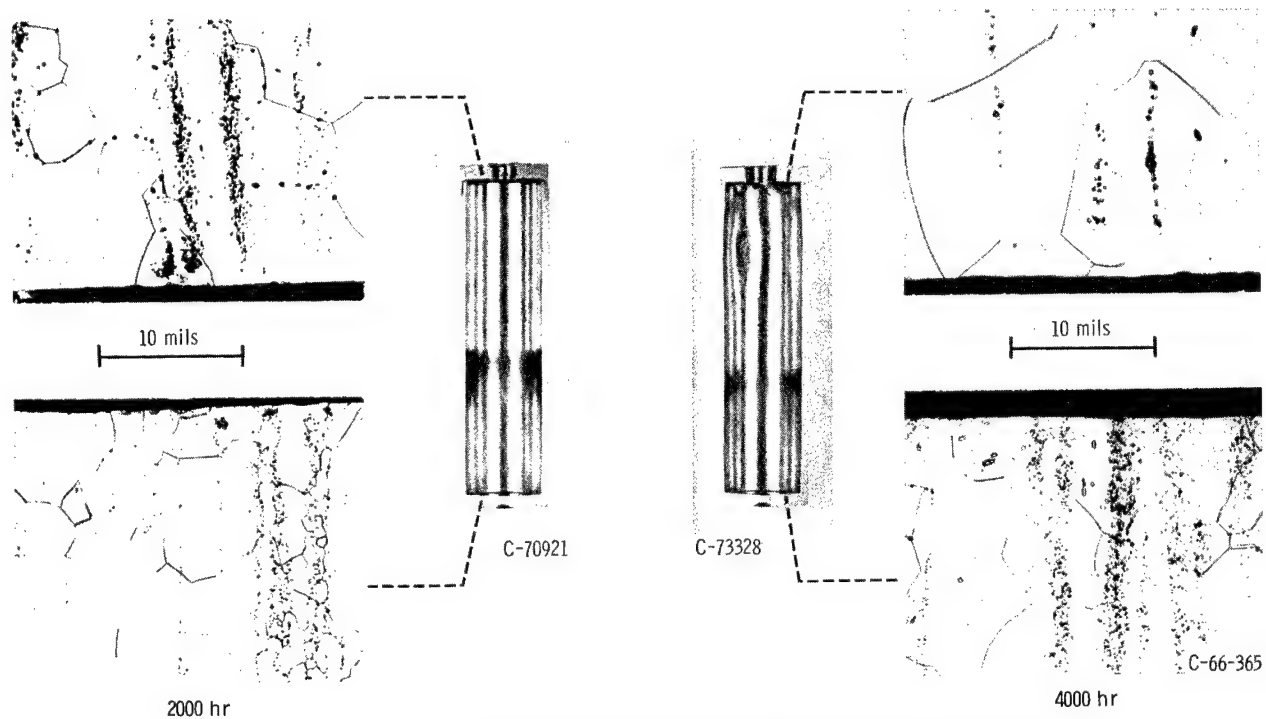
Figure 15. - Microstructures of B-66 capsules after testing at 2200° F with refluxing potassium.

Capsules of B-66 were tested at 2200<sup>0</sup> F for 2000 and 4000 hours. A dark film was found inside both capsules in the region of the liquid-vapor interface. Both capsules had slight amounts of grain delineation. An X-ray pattern of the film from the 4000-hour capsule revealed that it consisted of zirconium dioxide and columbium crystals. Metallography revealed no definite signs of gross corrosion in the capsule tested for 2000 hours, but a slightly irregular surface indicated solution attack to a maximum depth of about 0.2 mil in the condensing section of the capsule tested for 4000 hours. No gross precipitation was found in the as-received material (fig. 2(c)). In both of the test capsules, however, there were large amounts of a second phase appearing as precipitates strung out in bands parallel to the axis of the original rod stock (fig. 15). In general, precipitates were more numerous and smaller in the bottom of the capsules than in the top, these differences becoming greater with time. The precipitates were larger in the capsule tested for 4000 hours than in the capsule tested for 2000 hours. In addition, the capsule tested for 4000 hours showed a large grain growth in the condensing section throughout the wall thickness. The results of vacuum-fusion analyses on this capsule showed a great increase in oxygen concentration in the bottom section and a slight decrease in oxygen concentration in the top section.

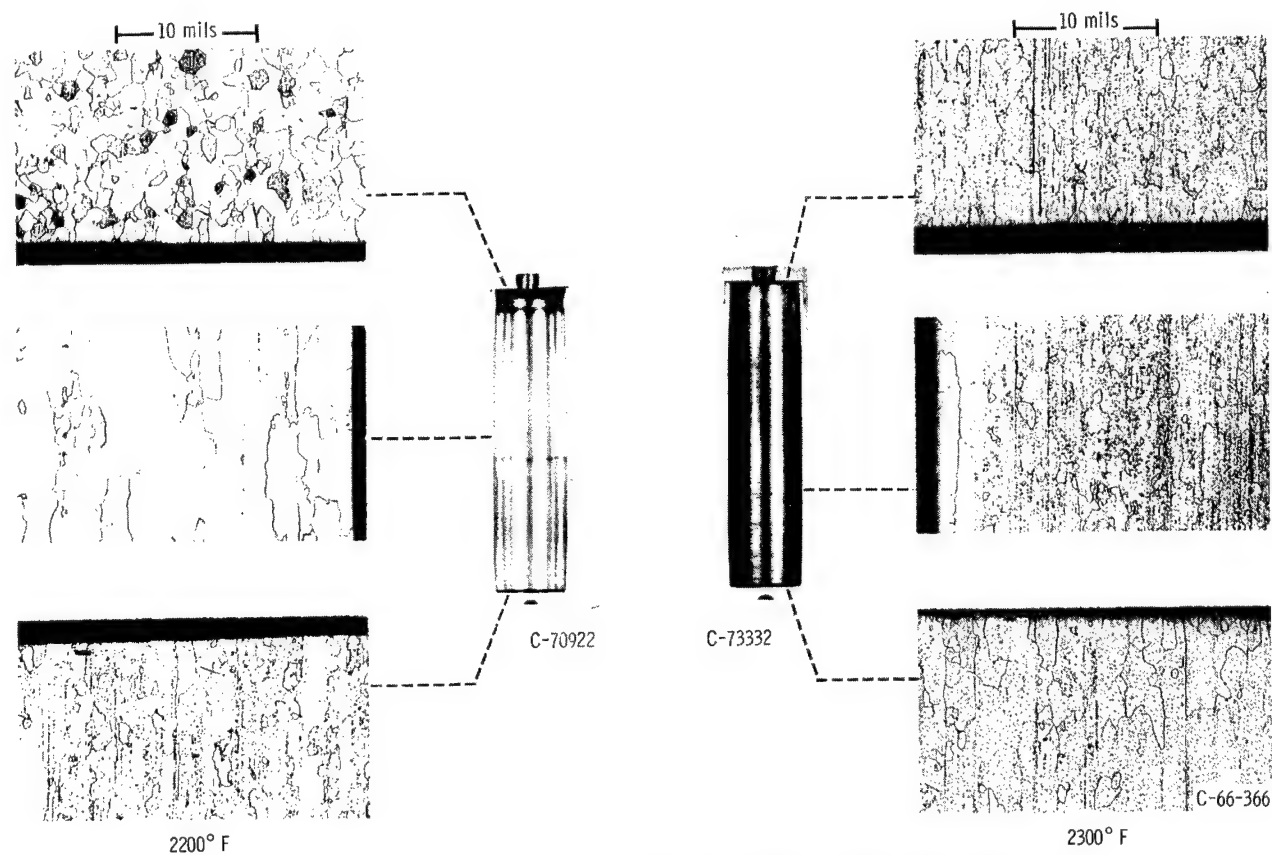
Figure 16. - Microstructures of D-43 capsules after testing for 2000 hours with refluxing potassium.

At 2200<sup>0</sup> F for 2000 hours, D-43 did not show corrosion effects except for a dark film at the liquid-vapor interface. Metallographic results showed small recrystallized grains in the very top of the capsule, the remainder of the capsule being only partially recrystallized with very fine precipitates throughout (fig. 16). The results of vacuum fusion analyses for oxygen in this capsule showed a greater increase in oxygen content in the bottom section than in the top section.

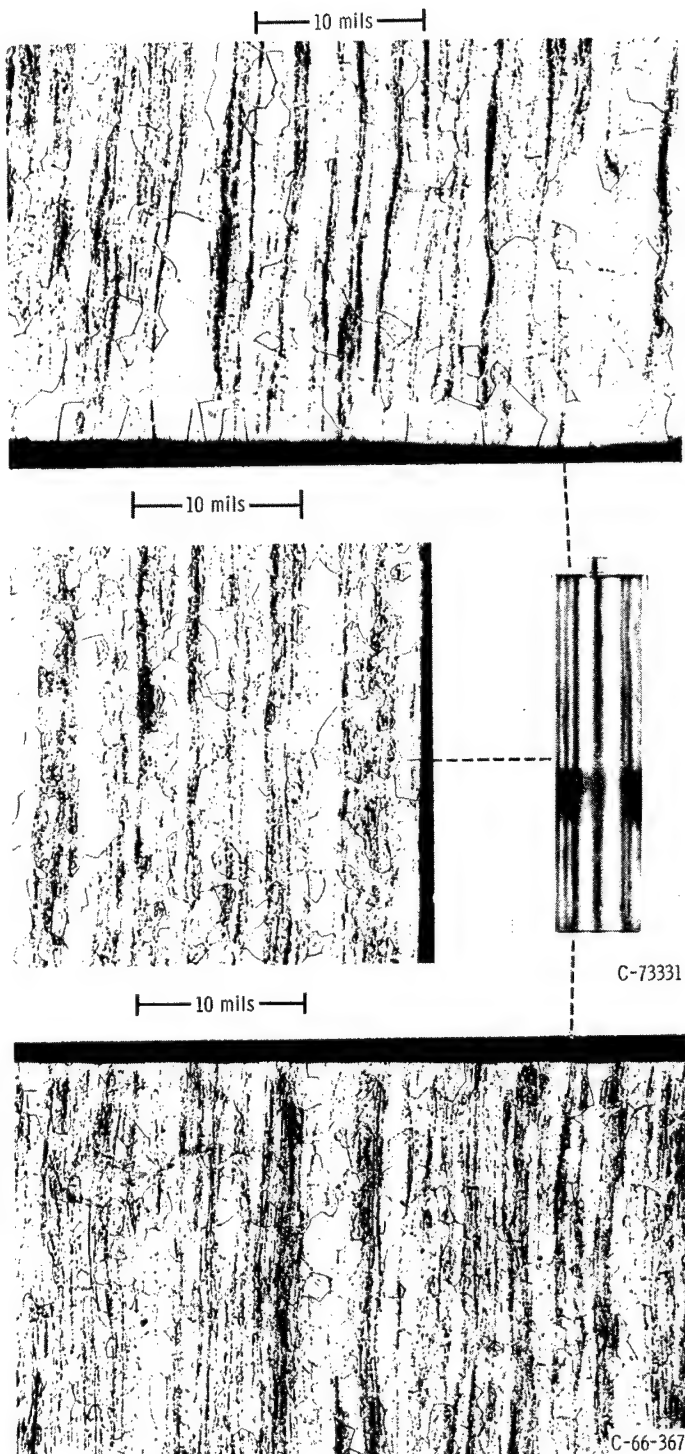
Figure 17. - Microstructures of FS-85 capsule tested at 2200° F for 4000 hours with refluxing potassium.

Capsules of FS-85 were tested at 2200° F for times up to 4000 hours, at 2300° F for times up to 2000 hours, and at 2400° F for 2000 hours. None of these tests showed any corrosion other than a fairly heavy film at the liquid-vapor interface. All of the capsules had recrystallized during testing. There appeared to be a precipitate-depleted zone along the inside edge of the capsules, predominantly in the condensing sections. The affected depths were up to 4 mils at 2200° F for 4000 hours, up to 7 mils at 2300° F for 2000 hours, and up to 6 mils at 2400° F for 2000 hours. The precipitates were strung out in bands parallel to the axis of the original rod stock. (For an example, see fig. 17.)

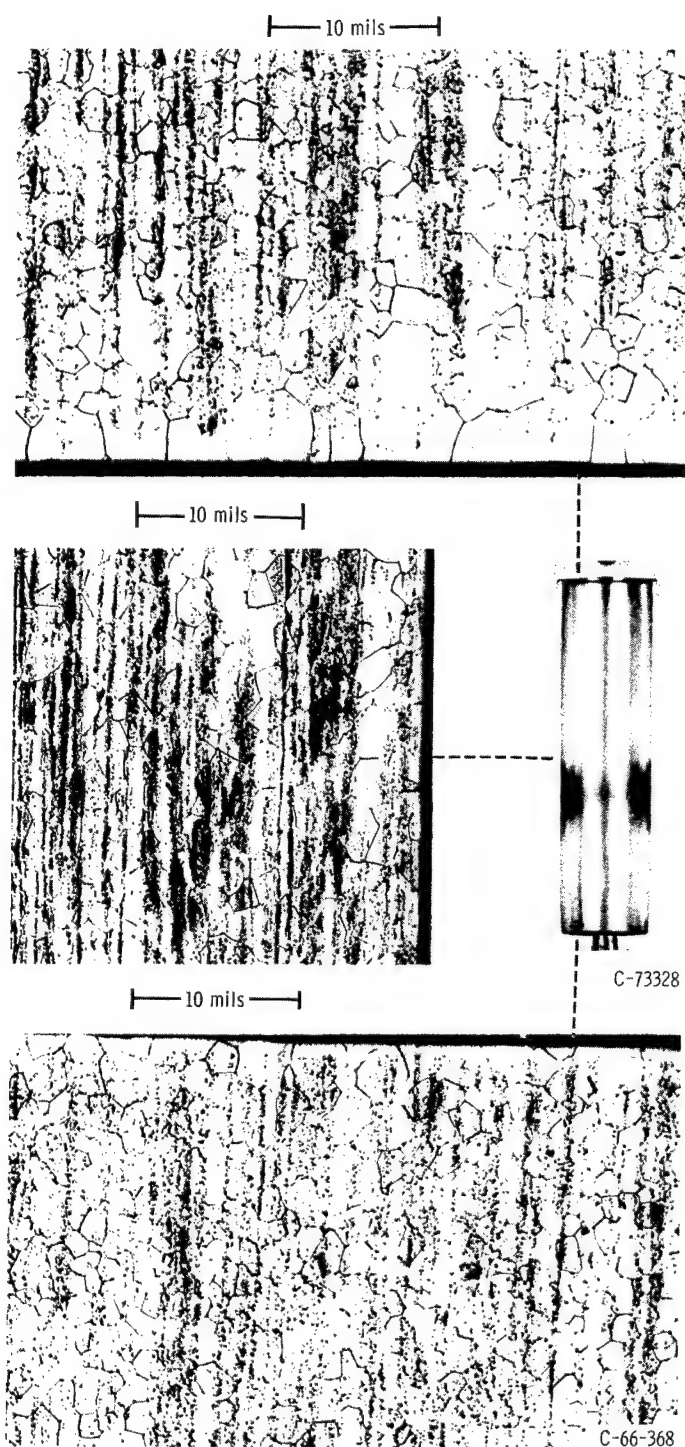
Figure 18. - Microstructures of Cb-752 capsule tested at 2200° F for 4000 hours with refluxing potassium.

Tests performed on Cb-752 at 2200° F for 2000 and 4000 hours resulted in no gross corrosion (fig. 18). As with most of the other gettered alloys of columbium, a heavy film developed at the liquid-vapor interface. The X-ray patterns of the film on the capsule that was tested for 4000 hours revealed the presence of two very small-grained columbium phases with slightly different lattice parameters and zirconium dioxide with about half the intensity of the columbium.

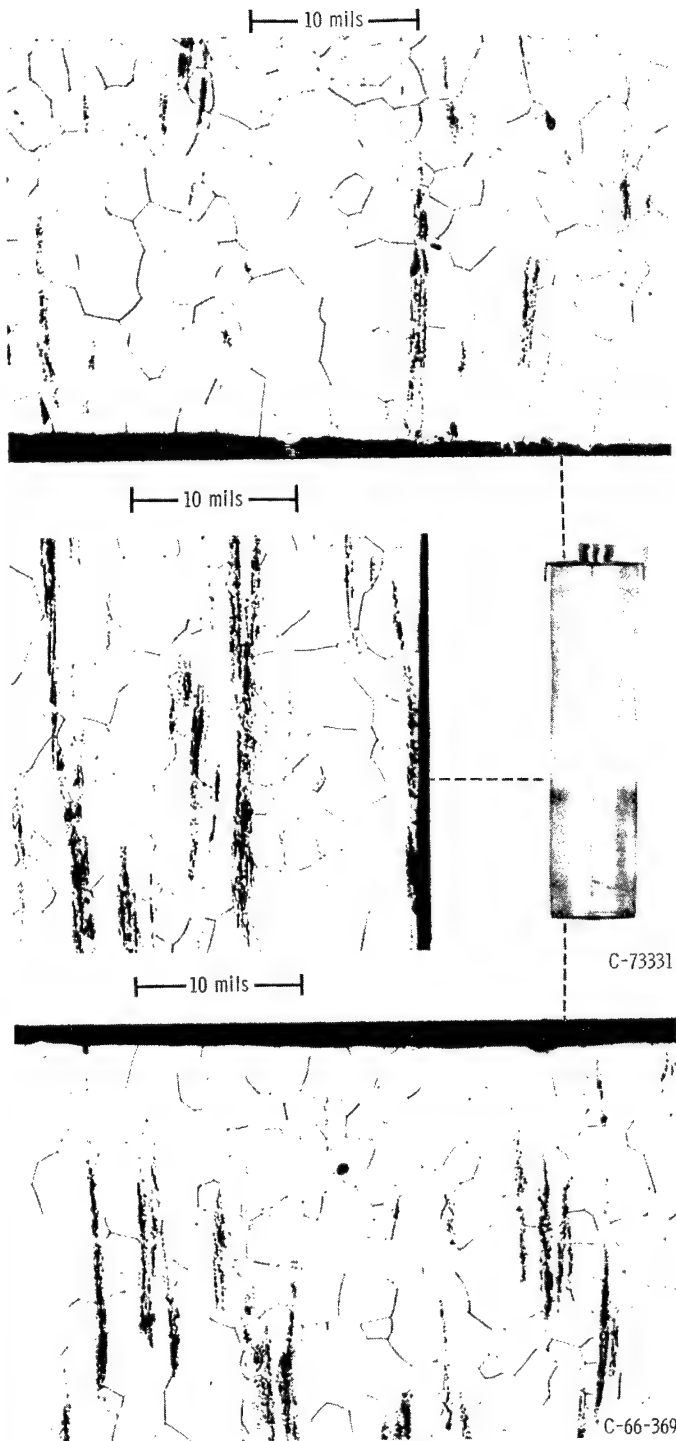
Figure 19. - Microstructures of C-129 capsule tested at 2200° F for 4000 hours with refluxing potassium.

The C-129 alloy, tested at 2200° F for 2000 and 4000 hours, indicated no gross corrosive attack. There were, however, grain delineation and a dark film at the liquid-vapor interface in both capsules (fig. 19).

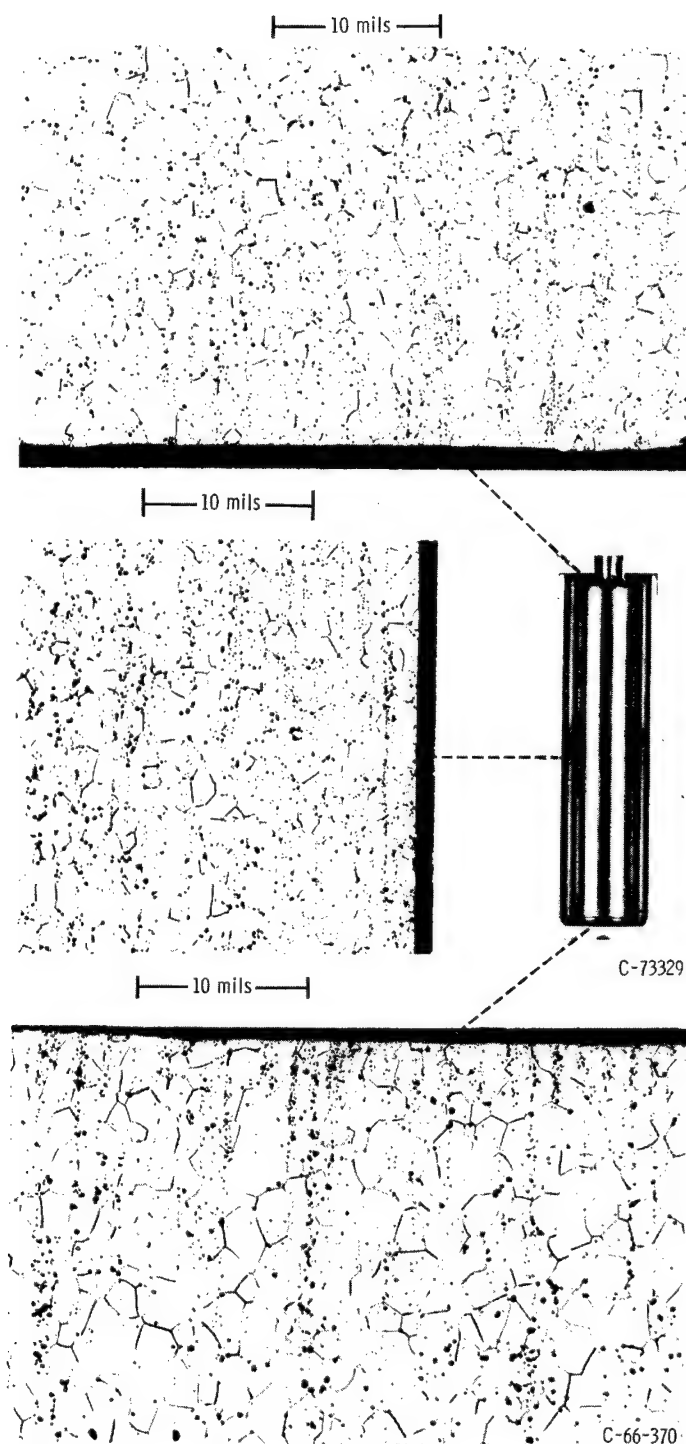
Figure 20. - Microstructures of T-111 capsule tested at 2300° F for 2000 hours with refluxing potassium.

Potassium had very little effect on T-111. Figure 20 shows a capsule tested at 2300° F for 2000 hours. This capsule was typical of those tested. The only effect seemed to be the formation of a faint film at the
